RM No. E7J23

CYCLIC ENGINE TEST OF CAST VITALLIUM TURBINE BUCKETS - I

By J. Elmo Farmer, F. N. Darmara  
and Francis D. Poulson

## NATIONAL ADVISORY COMMITTEE FOR AERONAUTICS

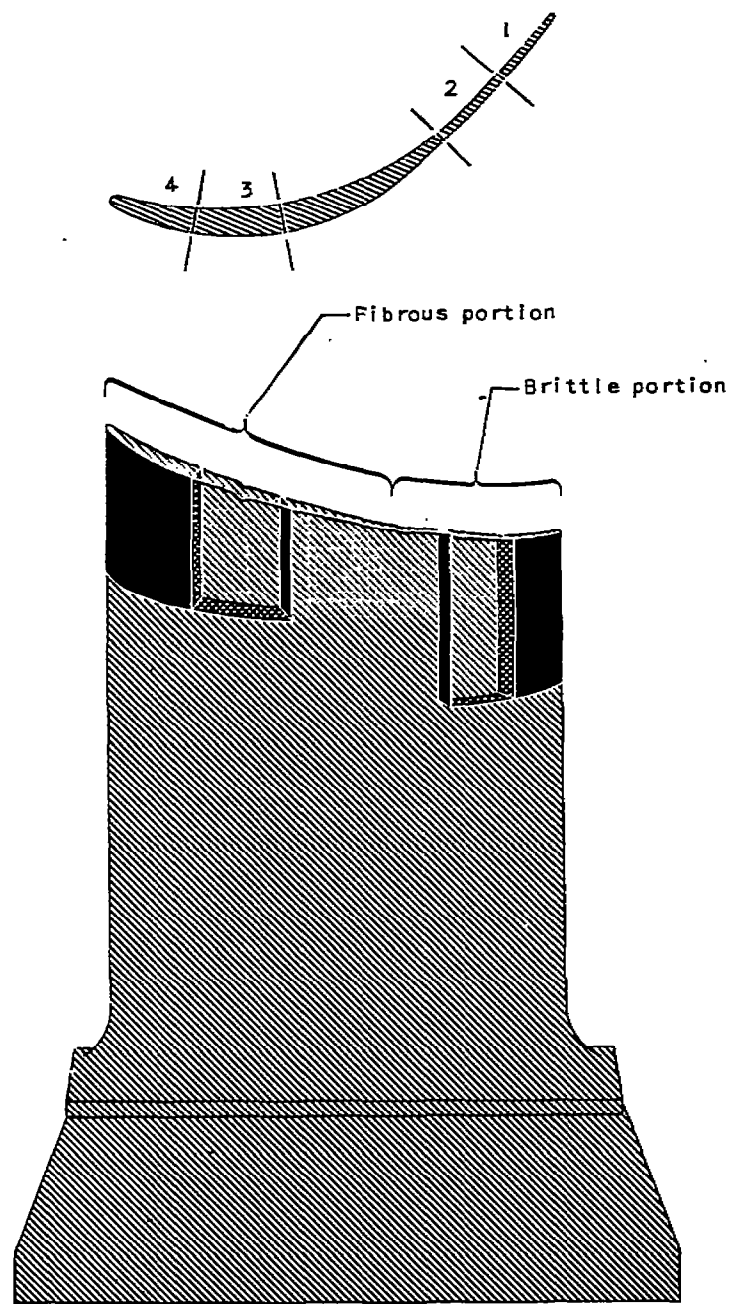
Microexamination. - Two samples were cut from both the leading and the trailing edges of the broken buckets. The locations from which the samples were taken are shown in figure 5. The samples were polished and electrolytically etched in hydrochloric acid.

Figure 5. - Sketch showing location of samples cut from broken turbine buckets for microexamination. Black areas indicate polished surfaces.

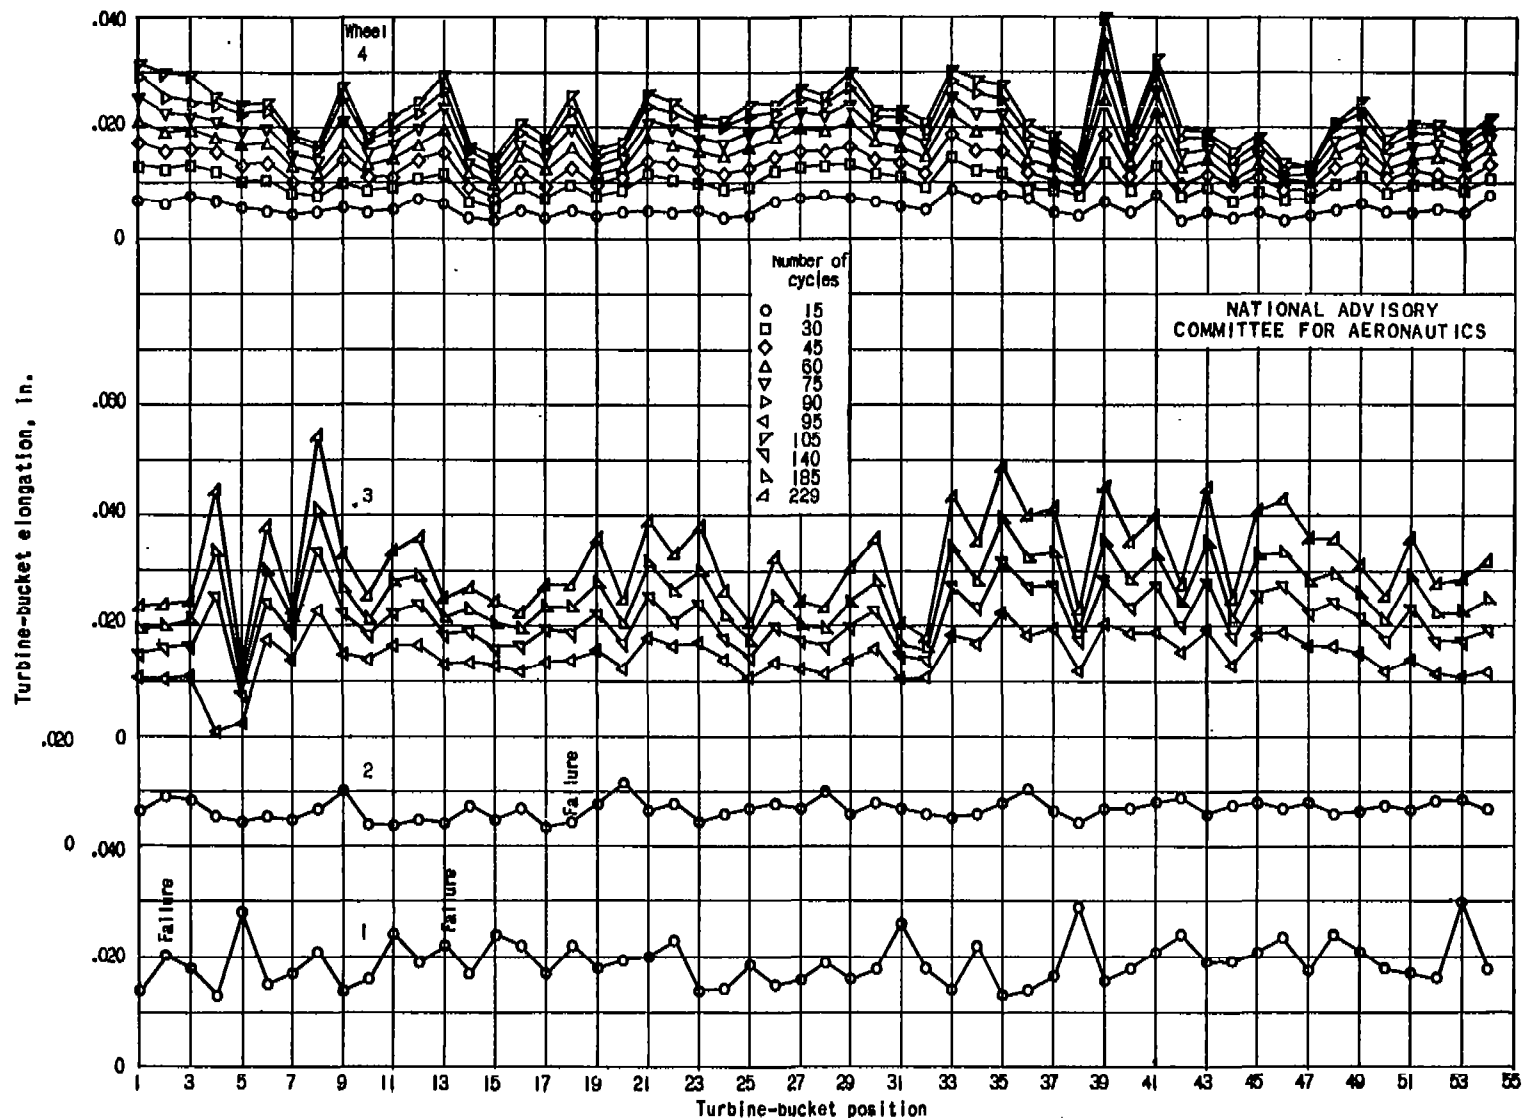
Turbine-bucket elongation. - The elongation of the turbine buckets for the four wheels is plotted in figure 12; the bucket failures are also indicated. The first bucket failures on wheels 1 and 2 so damaged the tips of all the other buckets that further measurements could not be made. The elongation data on wheels 3 and 4 are more complete; no bucket failures, however, have yet occurred on these wheels. All failures occurred at about the same distance from the bucket roots and the type of failure was the same in all cases (fig. 13).

Figure 12. - Variation of turbine-bucket elongation with time for four wheels investigated.

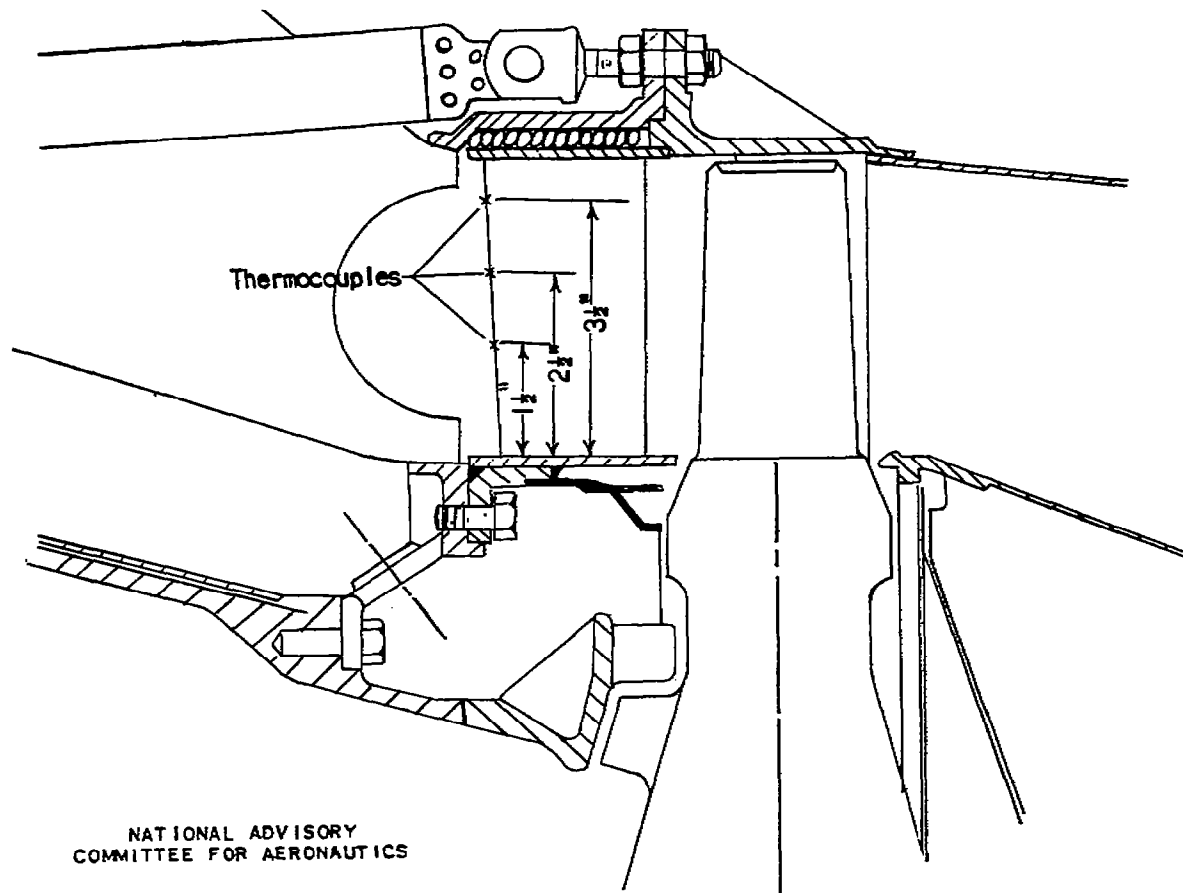
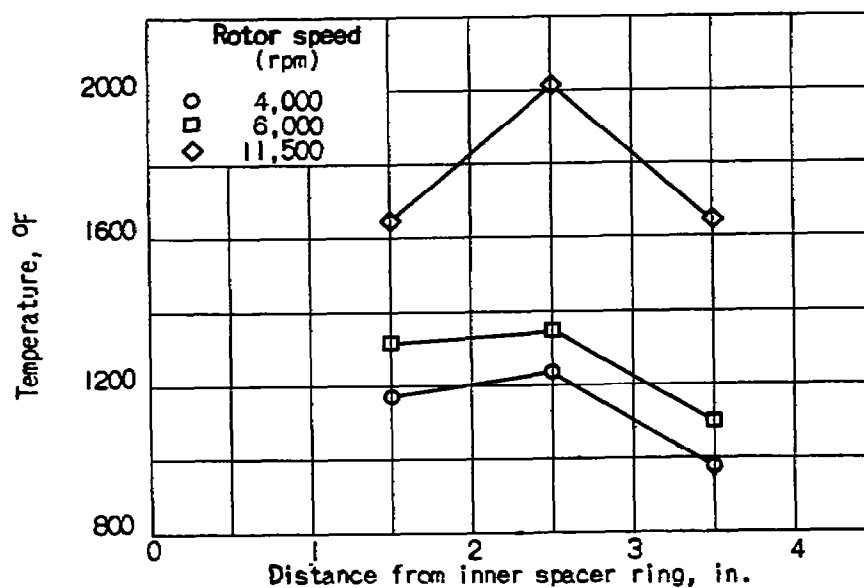
Nozzle-blade temperature. - The temperature variation along the leading edge of a turbine-nozzle blade located directly behind burner 1 is shown in figure 14. These temperatures were obtained by three chromel-alumel thermocouples located as shown in figure 14. The location of a thermocouple  $2\frac{1}{2}$  inches from the inner spacer ring was chosen because in previous nozzle-blade failures most of the cracks were near this position. The data indicate that the hottest portion of the nozzle blade is about  $2\frac{1}{2}$  inches from the inner spacer ring. The fractures on the trailing edge of the turbine buckets are approximately  $2\frac{1}{2}$  inches from the root. Because the turbine-nozzle blades and the turbine buckets are supported in a different manner, the temperature distribution in them may not be the same; the bucket failures occurred, however, at the same radial location as the maximum measured nozzle-blade temperature.

Figure 14. - Temperature variation along leading edge of turbine-nozzle blade on center line of burner 1 in turbojet engine at various rotor speeds.
